Mount Pleasant Churchstoke Powys 25 OCT 2019

Ecological Survey

September 2019

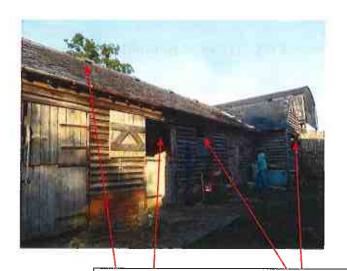
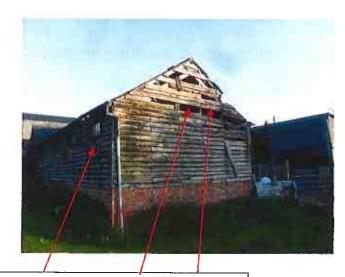
Areas of potential for Bats

Example of potential; beneath ridge tiles/ ridge vents, missing/displaced roof slates, missing/displaced shiplap boarding and open doors and windows

- 4.2 The barn is a single storey; softwood timber framed building weather proofed in shiplap on a brick base with the roof clad in natural slate.
- 4.3 The structure of the barn is in a reasonable condition, however there are areas of potential for bats to utilize/roost, i.e. beneath ridge tiles/ridge vents, missing/displaced roof slates, missing/displaced shiplap boarding and open doors and windows (see photographs Areas of potential for bats)

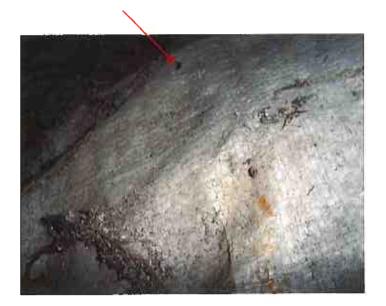
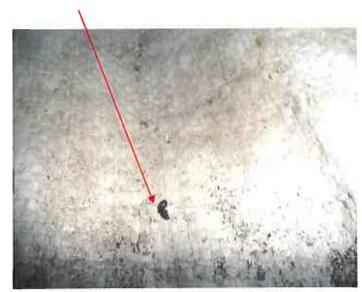
Bat droppings in barn

- 6.1 The initial survey was carried out on Monday 13th May 2019. The survey was carried out as described above. The surveyors noted several locations where bats may gain access to the barn i.e. beneath ridge tiles/ridge vents, missing/displaced roof slates, missing/displaced shiplap boarding and open doors and windows (see photographs Areas of potential for bats). There are several areas of ideal foraging and flight lines for bats surrounding the property, i.e. further agricultural buildings, hedgerows along lanes & fields and sporadic trees.
- 6.2 The interior of the barn was inspected thoroughly, where possible, with the aid of 1.5 million candle power lamps & endoscopes. A small number of bat droppings were found on bags stored within the southern aspect of the barn. (see Photographs 'Bat droppings in barn').

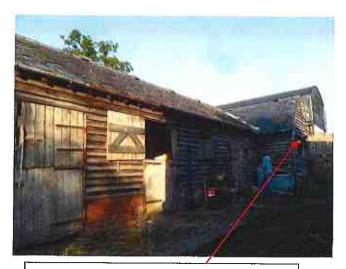
Bat emergence / access points

- 7.5 On 3/7/19 at 22:34hrs a Brown long-eared bat (*Plecotus auritus*) was observed emerging from a gap in a window at the northern aspect of the eastern elevation. At

22:35hrs a second Brown Long Eared bat was observed emerging from an open window at the southern aspect of the western gable (See photographs; "Bat Emergence and Access points"). Throughout the survey Common Pipistrelle bats (*Pipistrellus pipistrellus*) and Soprano Pipistrelle bats (*Pipistrellus pygmaeus*) were observed and detected foraging around the site, at 22:18hrs a Noctule bat was also detected within the area. This survey commenced at 21.20hrs and ended at 23.10hrs, sunset was at 21:38hrs.

Western elevation/ Gable - open window

Eastern elevation - gap in window.

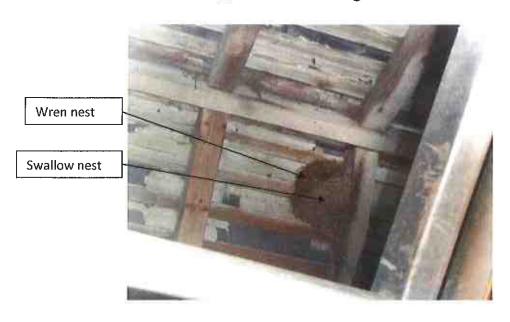
Evidence of nesting birds

- a) The surveyors first examined the outside of the barn. The purpose of this search was to locate any possible Barn owl (*Tyto alba*) access/egress points and to note any barn owl splashing (white faeces splashing) or discarded pellets (regurgitated fur and bones of small mammals, e.g. voles). or any other nesting birds.
- b) There was no evidence of Barn Owl presence within the barn however a Swallow (*Hirundo Rustica*)/ Wren (*Troglodytes troglodytes*) nest was observed within the barn (see photographs "Evidence of nesting birds")
